Technical Bulletin

Re: TR290616#1SJ : Roof Angel Specification

29/06/2016

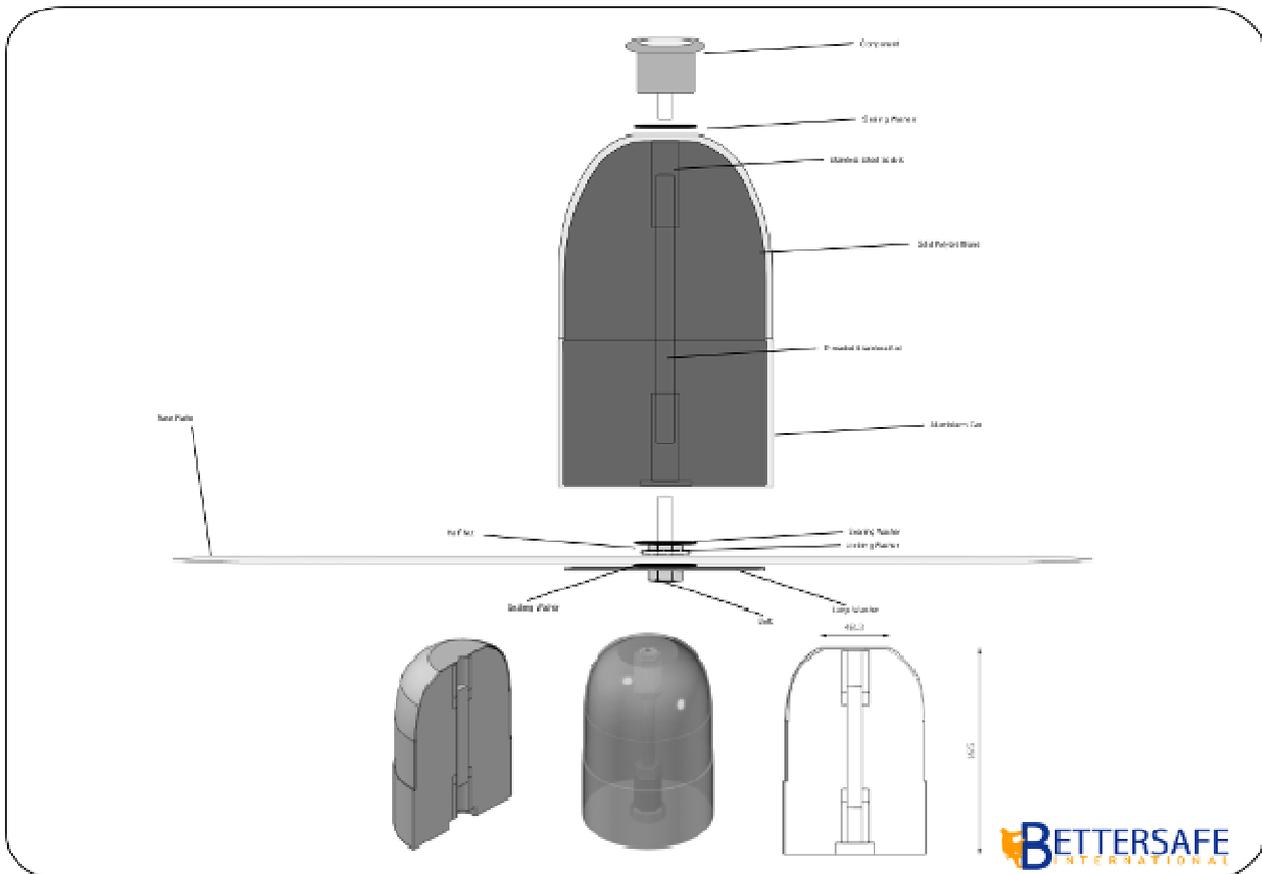
The Roof Angel Post when assembled has multi layers of prevention for degradation and also water penetration.

The Polyurethane Module is protected from UV degradation by the Aluminium Post Cover as shown here.

Water Penetration is prevented by a series of washers at the top of the Polyurethane Module and at the bottom of the Polyurethane Module, and also beneath the plate, which can be seen in the above illustration. The Polyurethane Module itself is solid and non-permeable to water.

Once installed the roof is protected from water ingress by either a sealing strip beneath the plate where it meets the roof sheet in the case of trapezoidal style sheeting systems, or by weather sealing to the base plate or similar in the case of membrane roofing systems.

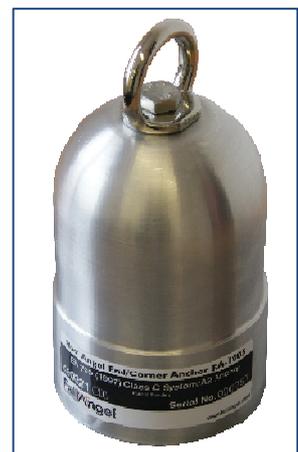
The Roof Angel Horizontal Lifeline System incorporates shock-absorbing, or load limiting components. Every post includes a Polyurethane Absorbing Module which collapses in the event of a fall.

The Roof Angel load limiting post is a moulding of Polyurethane around a Stainless Steel assembly of threaded rod and sockets. This assembly bends under extreme load also absorbing loads applied, whilst ensuring the retention of the mass or person.

The Polyurethane Module compresses in the direction of the fall which absorbs a large portion of the applied load and protects the fixings and the roof sheet or structure.

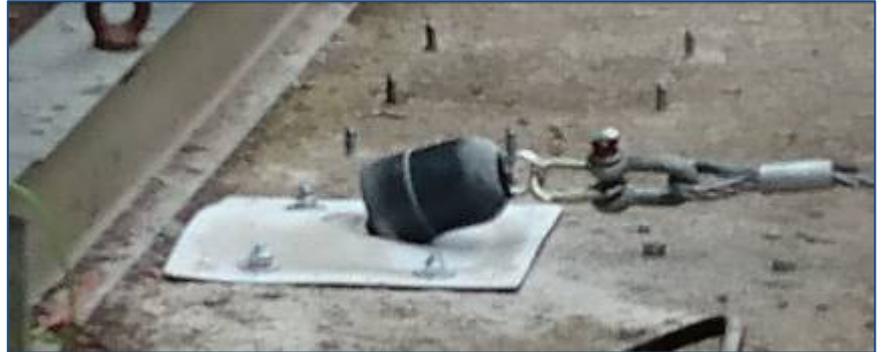
Image here shows the fall angel system during testing fixed to concrete.

It can be seen that the post has tipped over, is bent and the leading edge is compressed against the base plate.

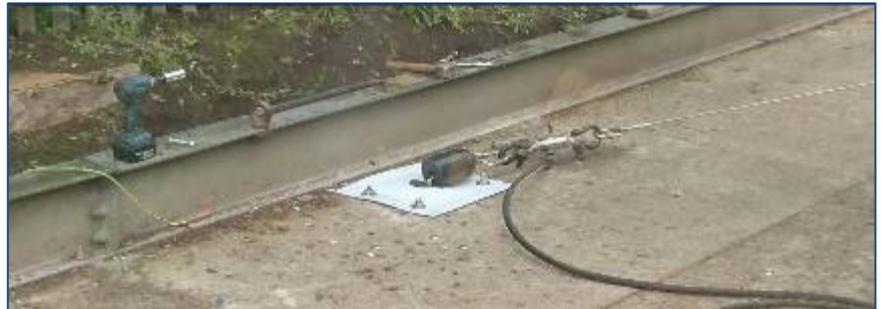
The image here shows the post after a 200kg mass has been arrested on a 15m single span, during the application of the 13kN static load for 3 minutes.

It can be seen in this image that the post has completely tipped and that the base plate has deformed. The connecting assembly inside the post can also be seen to be bent over.

Once the load is released the post relaxes but shows plastic deformation in both the post and the base plate caused by the absorption of the loads applied during the fall.

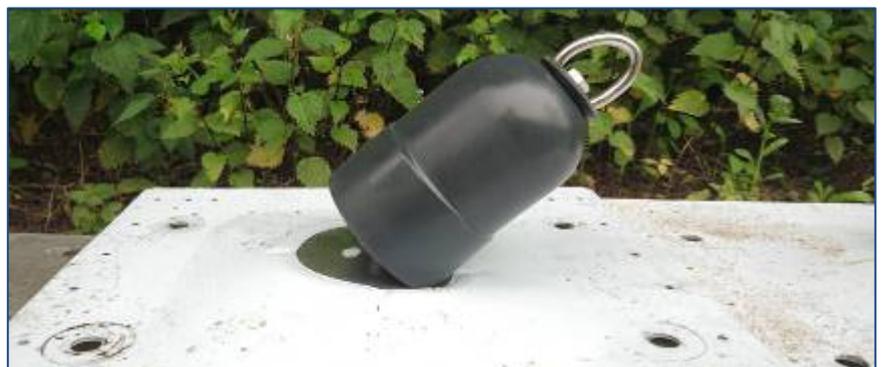
The image here shows the post after a 200kg load was arrested, and a subsequent applied 13kN load for 3 minutes was held as per the requirements of the tests.
